Memorandum

Date: 1 May 2020
To: Smithsonian Institution
From: Richard Kadlubowski
Subject: Investigations/Openings at SI CRC on 1 May 2020

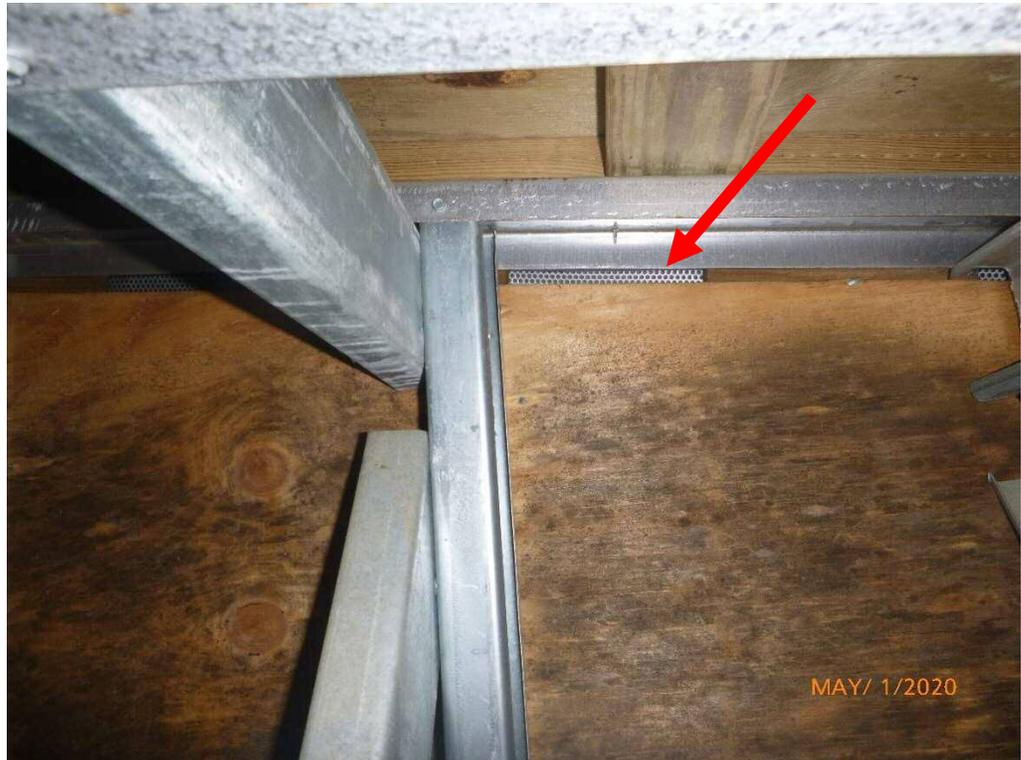
Photo 1: Opening No. 1. The interior surfaces of the parapet wall are not wet. Note the coping edge vent.

From what has been observed thus far, it appears that water is entering the parapet wall and wetting the exterior wall plywood. The mold growth is only on the exterior wall. (Photos 1 & 2) The edge vents on the coping are suspected to be the entry point. (Photo 3) Wind driven rain that hits the north wall, sheets upward on the surface of the overhang and is driven up into the edge vents and into the parapet wall interior. (Photo 4)

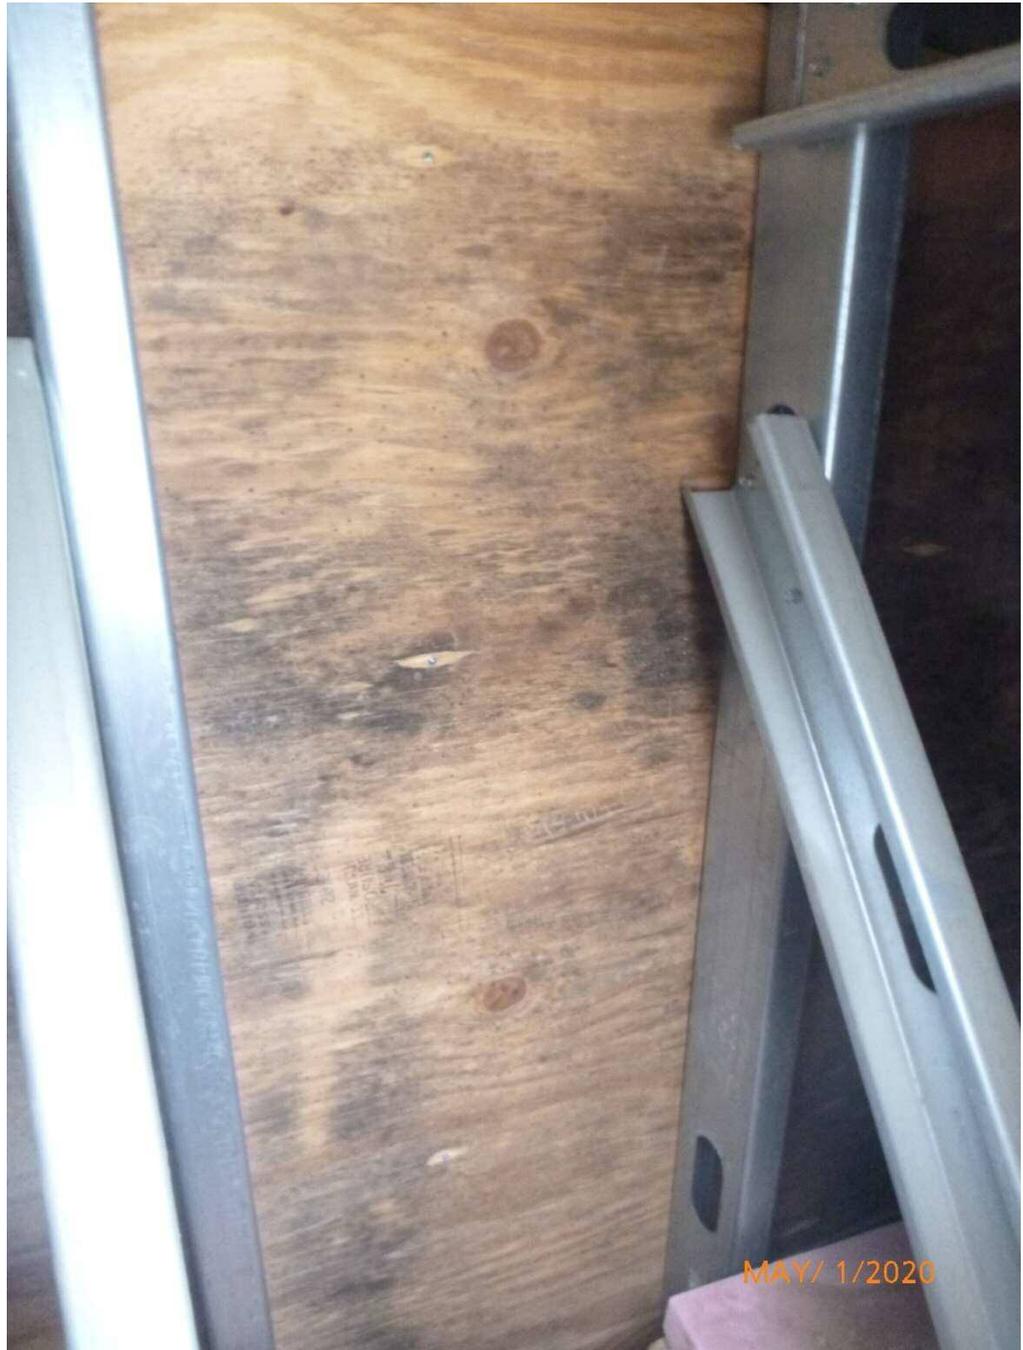
Photo 2: Opening No. 1. The plywood wall is not wet.

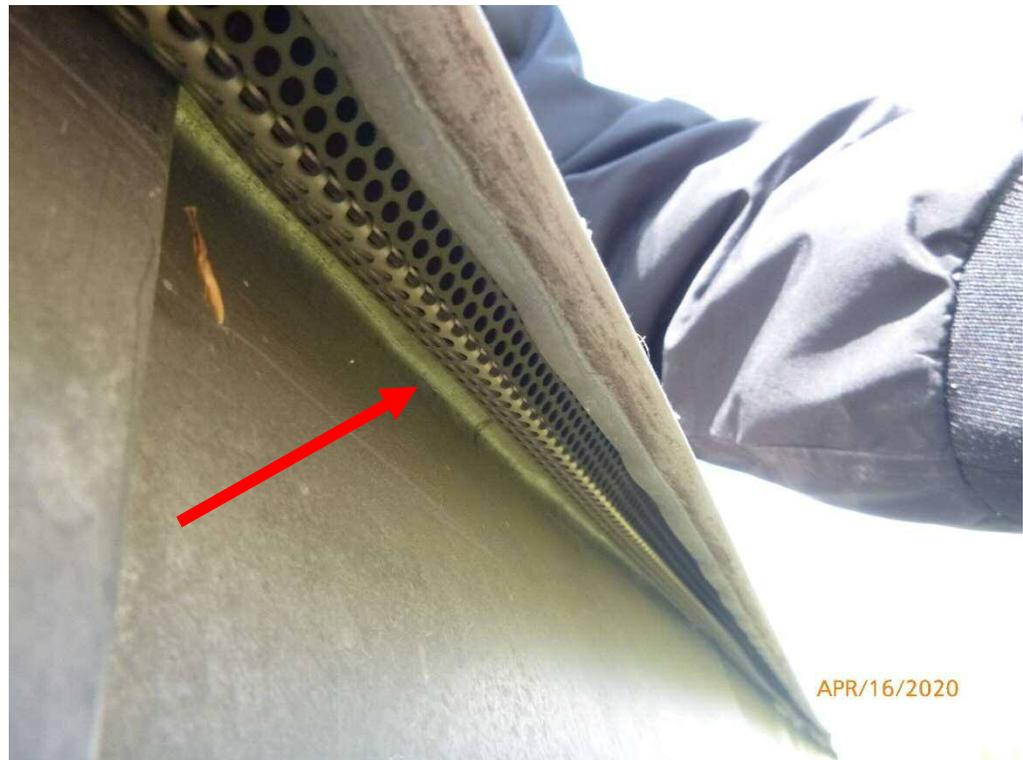
Photo 3: The parapet coping edge vents are a suspected entry point for water entry.

While the SI lift is in use at the exterior of the north wall to make the soffit opening, a water test will also be conducted at the coping and edge vents to ascertain if water does enter at that location. If it is found that the coping edge vents do allow water entry, they can be sealed during these operations.

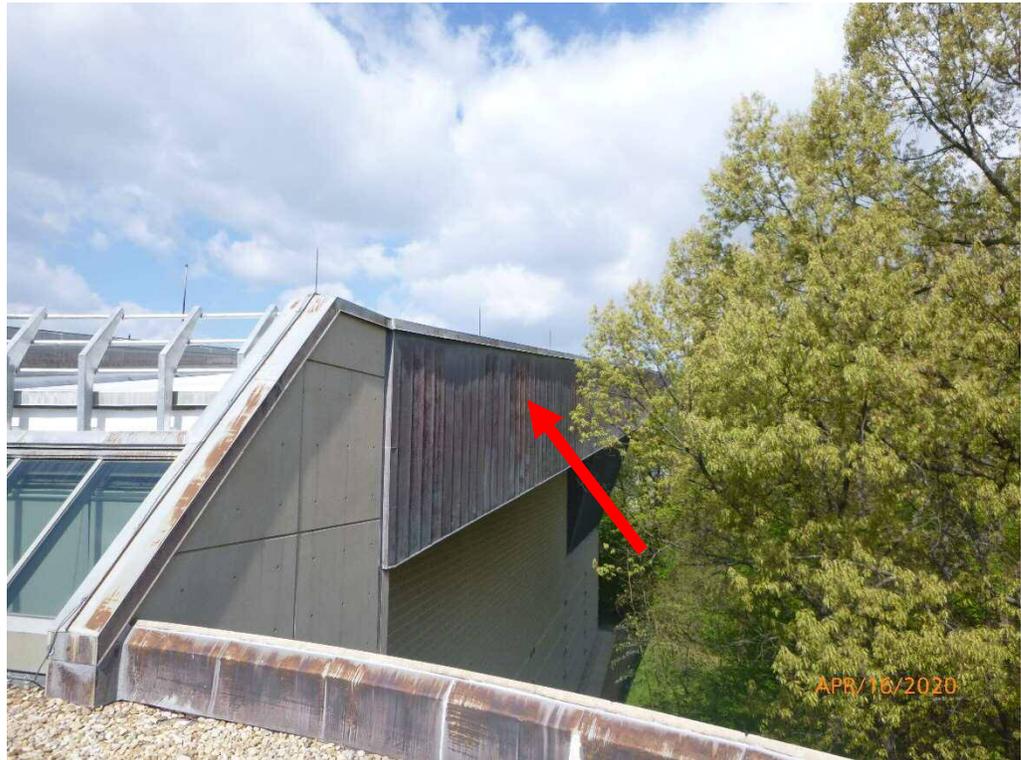
Photo 4: The face of the overhanging roof is exposed to wind-driven rains.

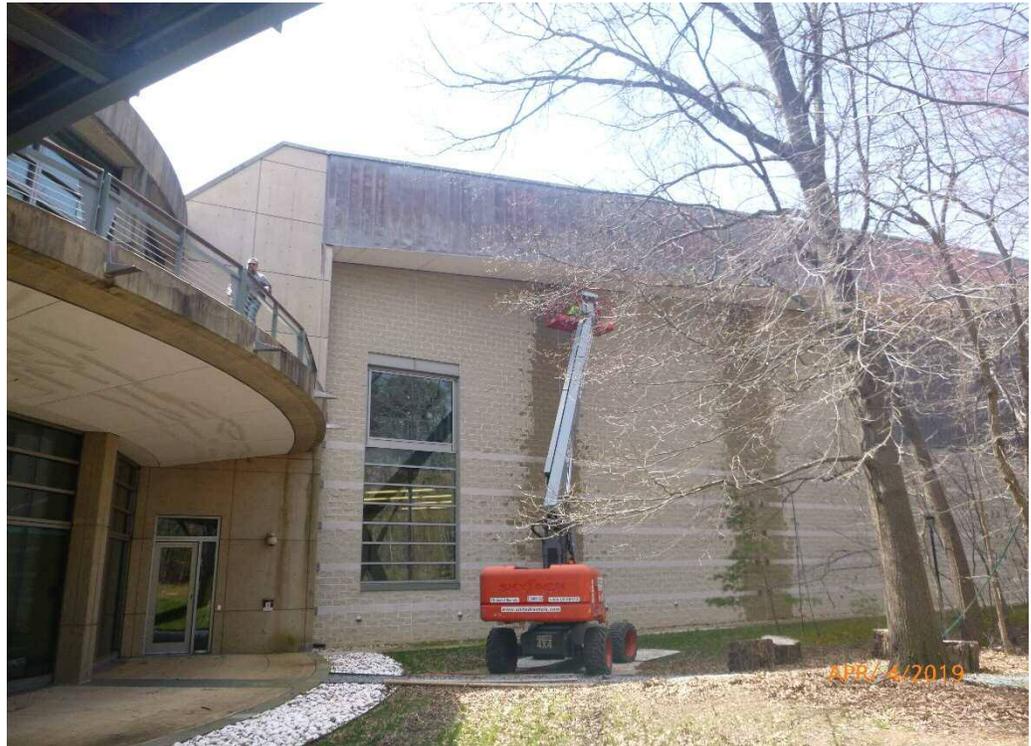
Photo 5: Proposed location on the underside of the overhang and coping water tests.

For the opening in the soffit, underside of the overhang, Vatica requested permission to install a ceiling access door in lieu of repairing the plaster soffit. The access door would allow for access into this space as needed for maintenance.

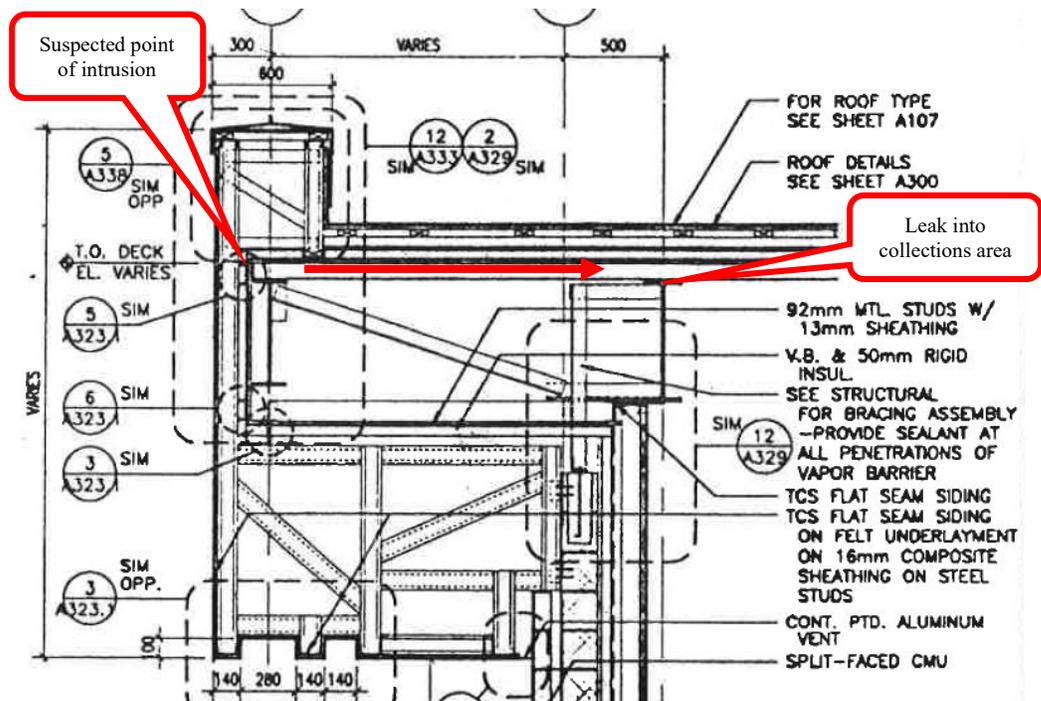
Photo 6: Suspected leak path.
